Guide for judging condition of piston-running components

LINERS, PISTONS AND PISTON RINGS
Version 6.0 November 2024

WIN GD

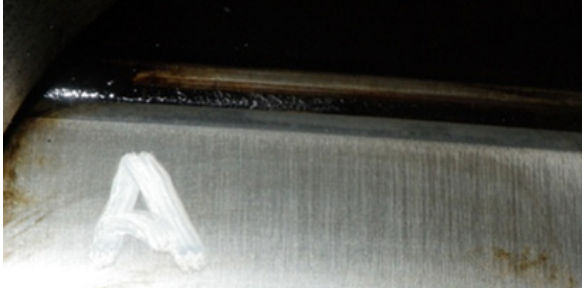
Ring type: SCP1CC20, A ring
Condition: Abrasion (3 body abrasion) can be caused by catalyst fines in fuel oil, or foreign hard particles (e.g. sand in intake air).
Acceptance: Acceptable
Action: See WinGD Fuel Guideline - www.wingd.com/en/technology-innovationengine-technology/engine-design/tribology-fuels-lubricants/

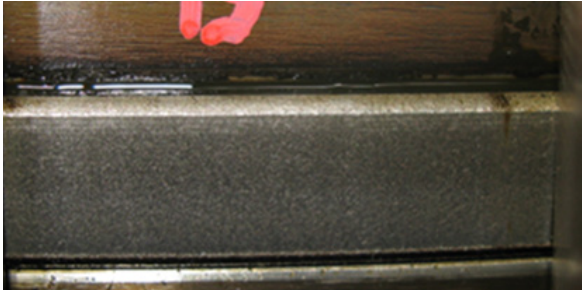
Ring type: SCP1RC16, B ring
Condition: RC running-in coating in spotless condition
Acceptance: Acceptable
Action: No action required

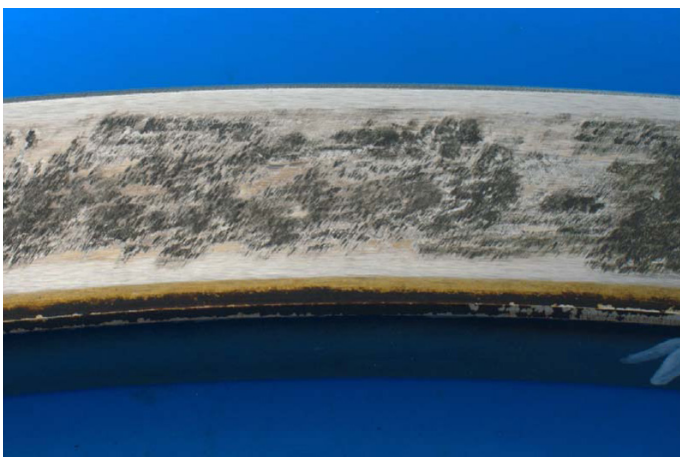
Ring type: GTP1CF24, A ring
Condition: Bottom face Cr coating fretting
Acceptance: Acceptable
Action: No action required

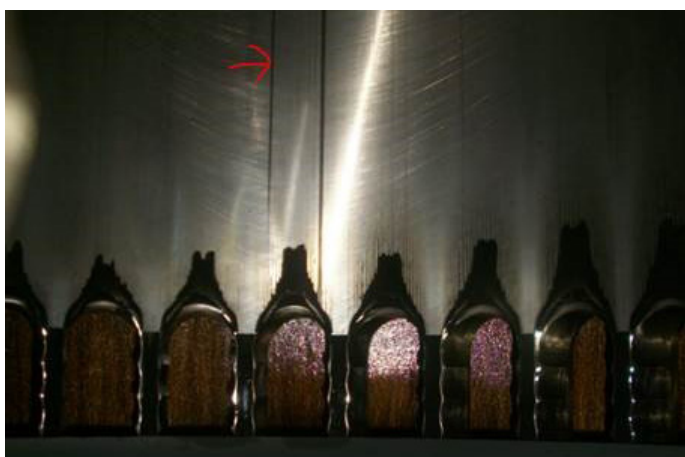
Condition: Single scratches on liner surface
Acceptance: Normal
Action: No action required

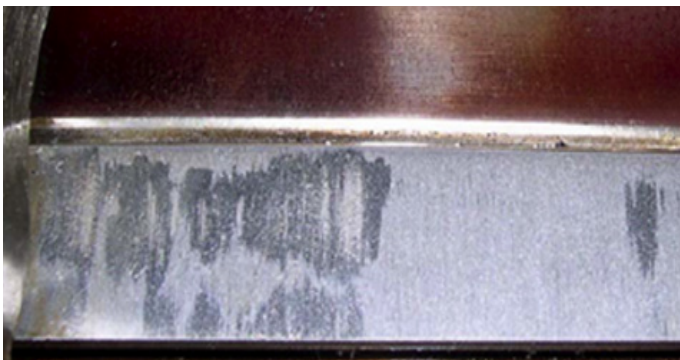
Ring type: SCP1RC20, B ring
Condition: Hard contact marks, RC coating gone, ring running on base material
Acceptance: To be monitored. Piston ring may recover
Action: Check entire ring surface. Temporary increase of set feed rate by 0.2 g/kWh and if possible reduce fuel injection correction factor in the engine control system. Consider exhaust gas deviation alarm.

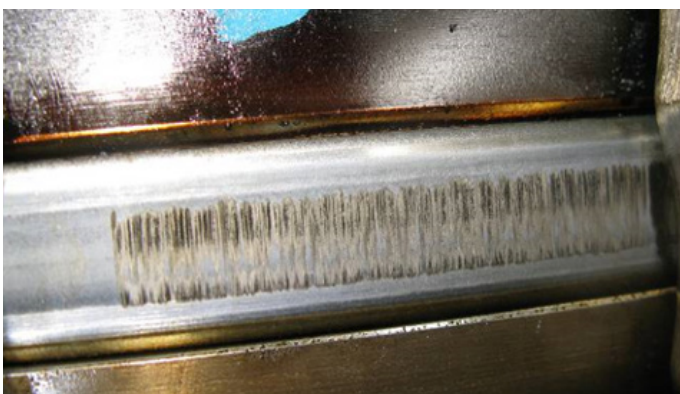
Ring type: SCP1CC20, B ring
Condition: Scoring marks
Acceptance: To be monitored. Piston rings may recover
Action: Check entire ring surface. Temporary increase of set feed rate by 0.2 g/kWh and if possible reduce fuel injection correction factor in the engine control system. Consider exhaust gas deviation alarm.

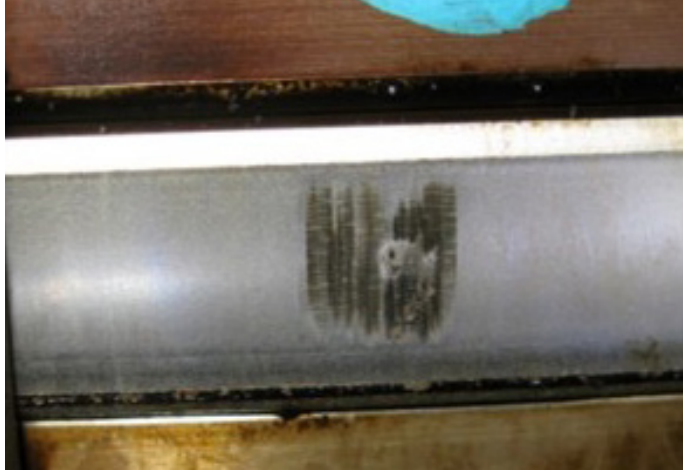
Ring type: SCP2CC20, C ring
Condition: Hard contact marks, scoring marks and initial coating spalling
Acceptance: To be monitored. Piston rings may recover
Action: Check entire ring surface. Temporary increase of set feed rate by 0.2 g/kWh and if possible reduce fuel injection correction factor in the engine control system. Consider exhaust gas deviation alarm. Local dressing up of hard contact marks with emery cloth (80 grain size) through scavenging air ports.

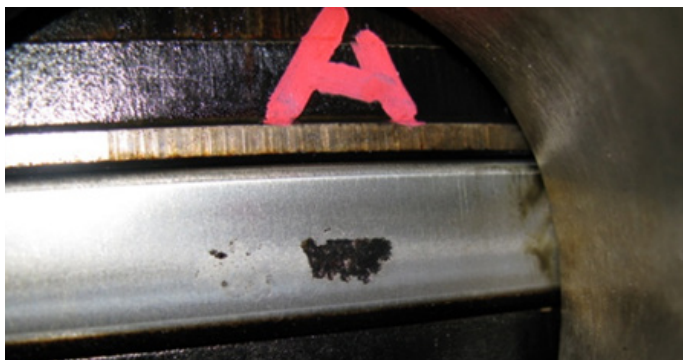
Ring type: SCP1CC20, A ring
Condition: Cracked CC coating and spalling
Acceptance: To be monitored. Limited size of spalling
Action: Check entire ring surface. In case spalling is less than 20 mm in length and less than half of the ring height the condition is still acceptable

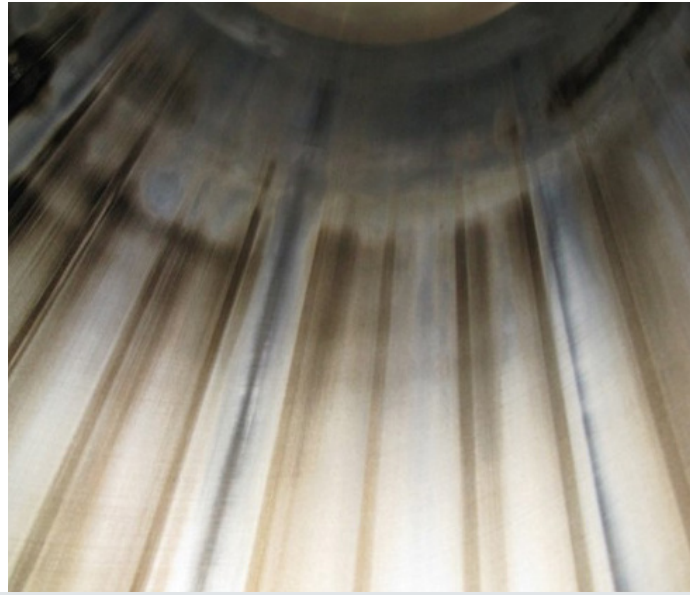
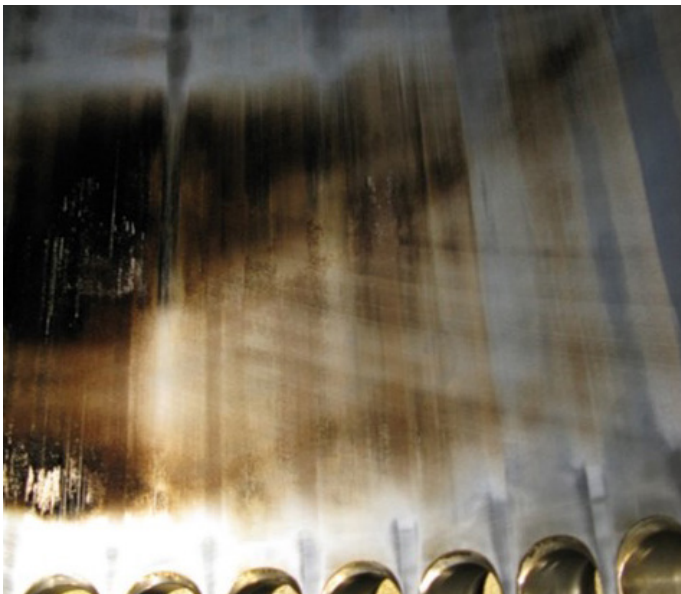
- Condition:** Cylinder liner with black lacquer and cold corrosion
Acceptance: To be monitored
Action: Check correct cylinder oil BN and feed rate setting.

The formation and extent of this lacquer formation depends mainly on engine load, sulphur content in fuel oils (~2.7% or higher), set cylinder oil feed rate and air humidity. Experience has shown that the black spots appear and disappear, depending on different operational parameters. They do not have a negative effect on the piston running conditions however they are an indication for cold corrosion.

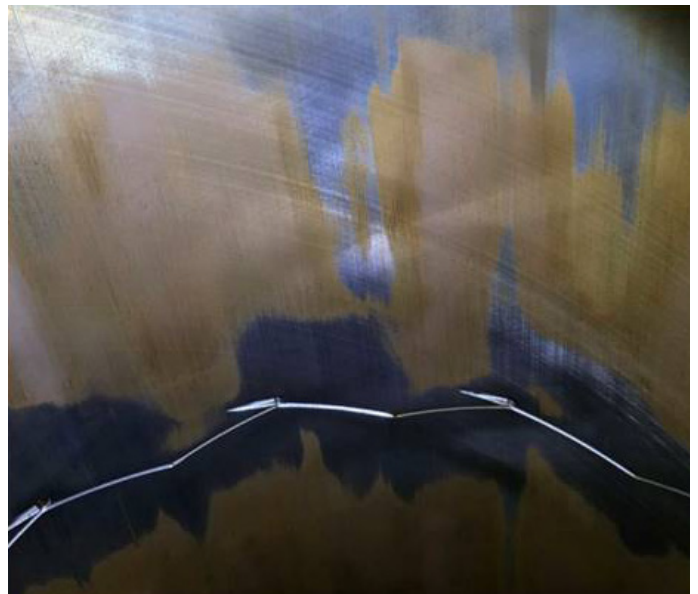
- Condition:** Rust spots on liner surface
Acceptance: To be monitored
Action: Source of water leak to be found and rectified. In case the rust has appeared because of longer standstill in a humid environment, it is recommended to perform approximately 200 manual lubrication pulses while operating the tuning gear for at least one full rotation of the crankschaft. Repeat this every 24 hours during standstill period.

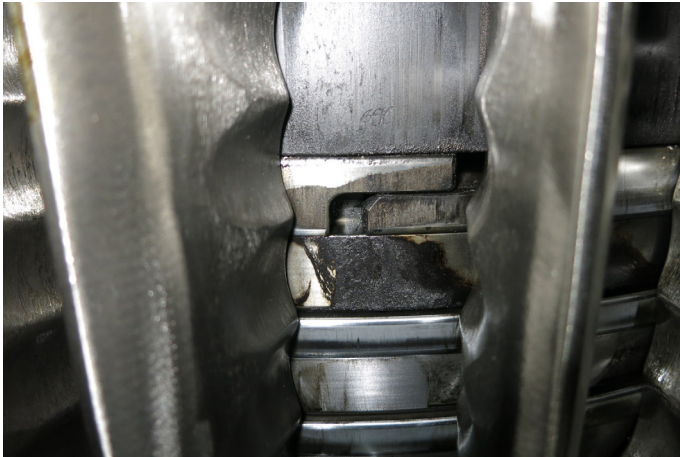
Ring type: GTP1CC20, A-ring
Condition: Local scoring / scuffing of ring gap ends
Acceptance: Critical, to be monitored very closely.
Action: Local dressing up of ring end gaps with emery cloth (80 grain size) through scavenging air ports. If condition deteriorates, then piston ring to be replaced and scorings on liner to be dressed up

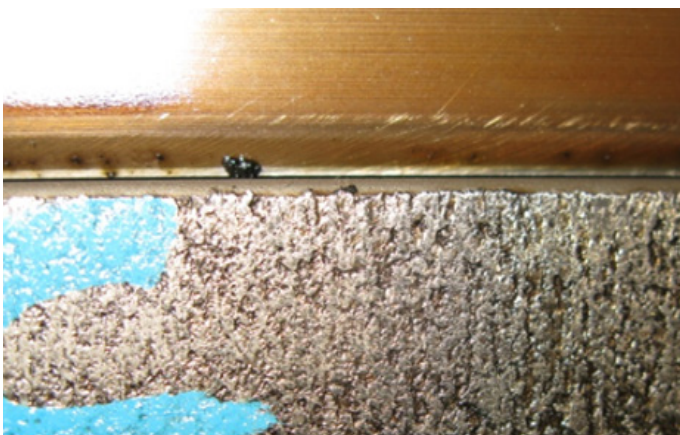
Ring type: SCP2CC20, C ring
Condition: Scuffed with some CC remaining active scuffing
Acceptance: Critical condition
Action: Unit to be overhauled. Temporary increase of set cylinder oil feed rate by ~0.2 g/kWh and reduce fuel injection correction factor in the engine control system until unit is overhauled. Consider exhaust gas deviation alarm. If ships schedule permits it, switch off the unit, till unit is overhauled.

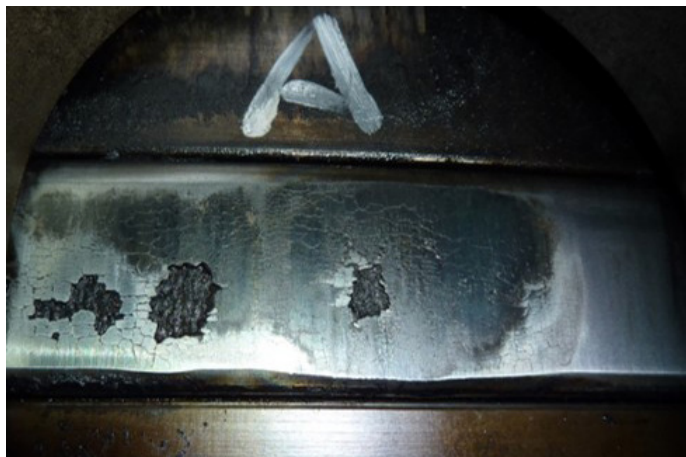
Ring type: GTP1CF24, A ring
Condition: Locally scuffed, CC coating destroyed and spalling, scuffing not active
Acceptance: Critical condition
Action: Unit to be overhauled. Temporary increase of set cylinder oil feed rate by ~0.2 g/kWh and reduce fuel injection correction factor in the engine control system until unit is overhauled. Consider exhaust gas deviation alarm

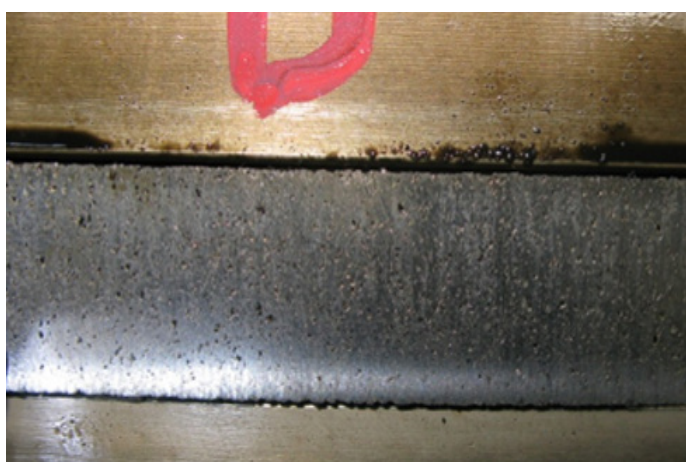
Ring type: SCP2CC20, D ring
Condition: Partly recovered from scuffing, sharp edges with burrs, coating worn down
Acceptance: Critical condition
Action: Unit to be overhauled. Temporary increase of set cylinder oil feed rate by ~0.2 g/kWh and reduce fuel injection correction factor in the engine control system until unit is overhauled. Consider exhaust gas deviation alarm

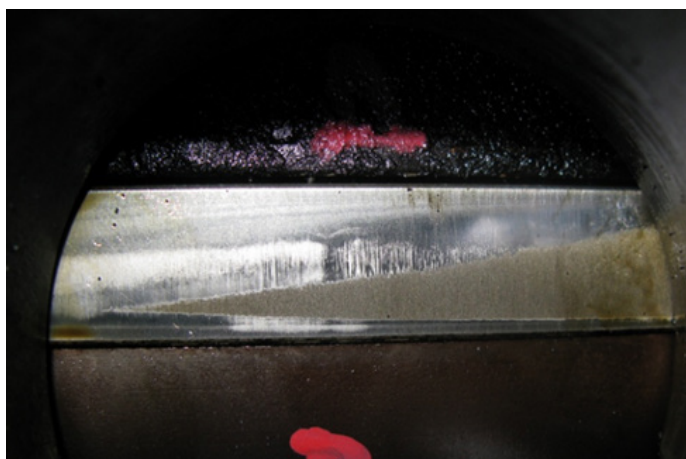
Ring type: SCP1CC20, A ring
Condition: CC coating worn down to base material, corrosion on remaining CC coating
Acceptance: Critical condition, further operation of such rings will result in a greater liner wear and increased risk for scuffing
Action: Unit to be overhauled
Remark: See next picture for possible root cause

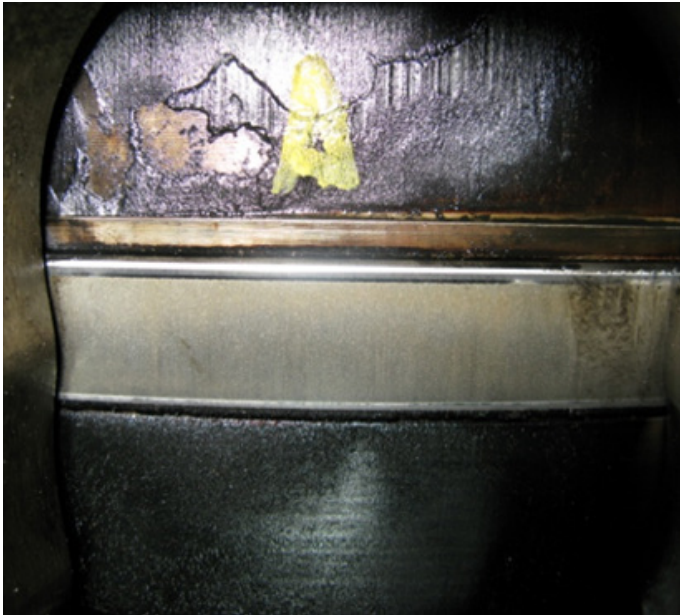
Ring type: SCP1CC20, A ring
Condition: Completely worn CC coating
Acceptance: Critical condition, further operation of such rings will result in a greater liner wear and increased risk for scuffing.
Action: Unit to be overhauled

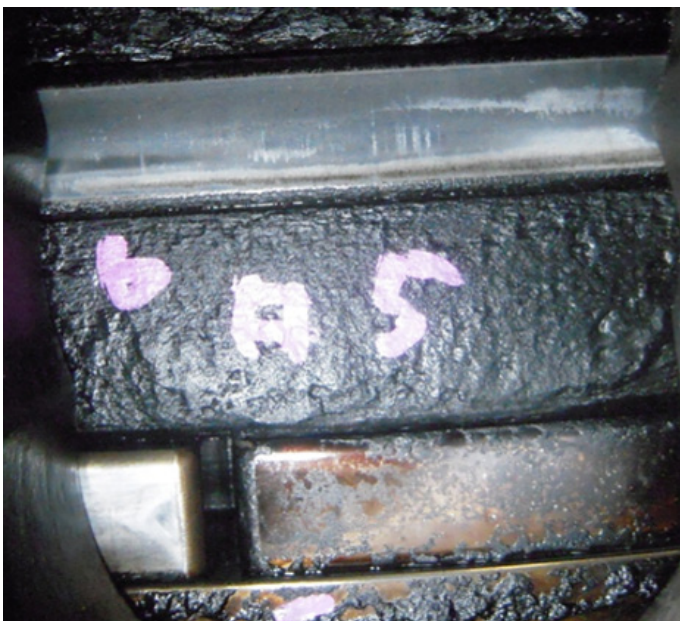
Ring type: SCP1CC20, A and B ring
Condition: A ring with some corrosion, B ring lost tension, with excessive deposits, cylinder oil feed rate, BN and fuel oil sulphur content not matching
Acceptance: Critical condition
Action: Unit to be overhauled. Check correct cylinder oil feed rate setting. Check residual BN in piston underside drain oil.

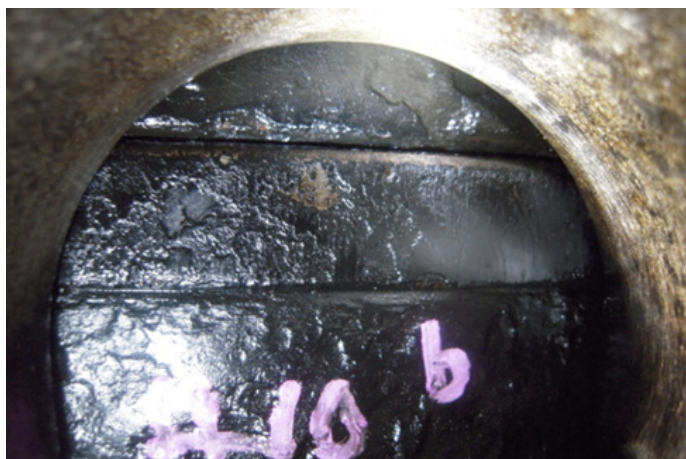
Ring type: SCP1CC20, A ring
Condition: Ring collapsed, with excessive deposit
Acceptance: Critical condition
Action: Unit to be overhauled. Switch-off unit

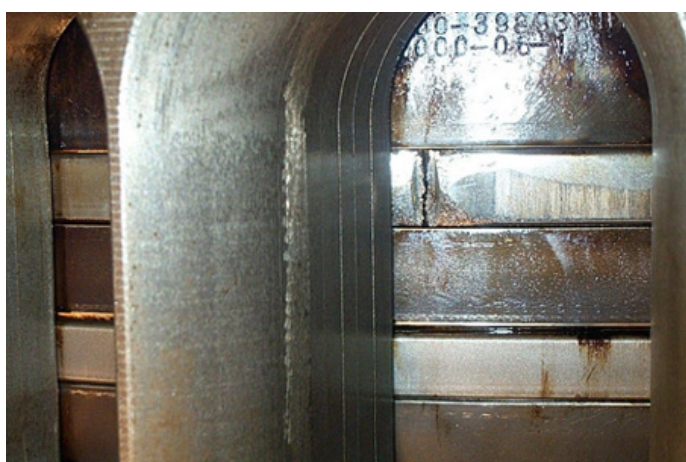
Ring type: SCP1CC20, A ring
Condition: Ring broken
Acceptance: Critical condition
Action: Unit to be overhauled. Switch-off unit

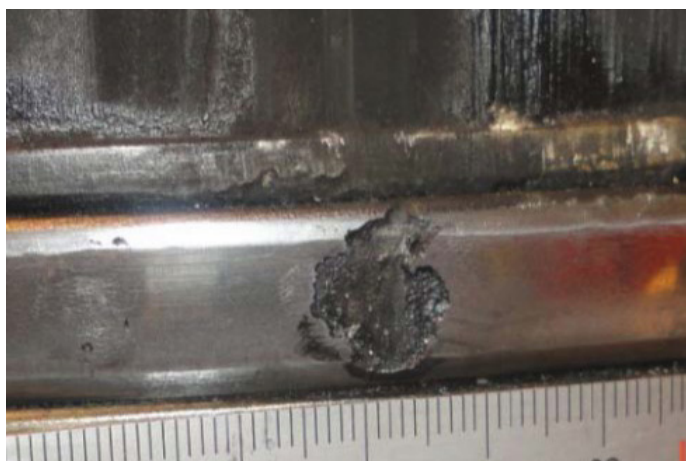
Ring type: SCP1CC16, A ring
Condition: A ring with excessive spalling across full ring height
Acceptance: Critical condition
Action: Unit to be overhauled. Temporary increase of set cylinder oil feed rate by ~0.2 g/kWh and reduce fuel injection correction factor in the engine control system until unit is overhauled. Consider exhaust gas deviation alarm

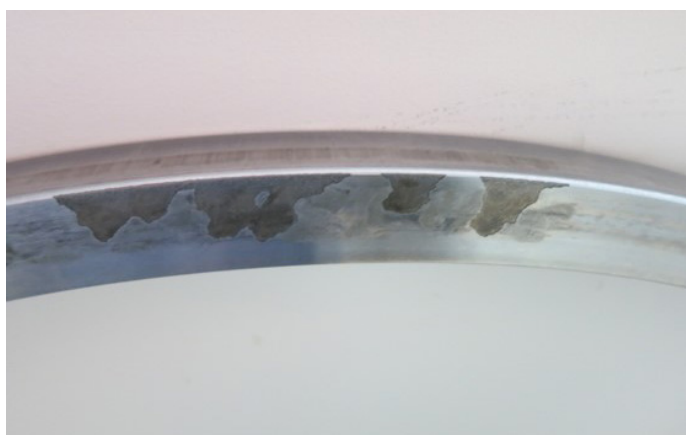
Ring type: GTP1CF24, A ring
Condition: Bottom face Cr coating spalling
Acceptance: Critical condition
Action: Piston ring to be replaced

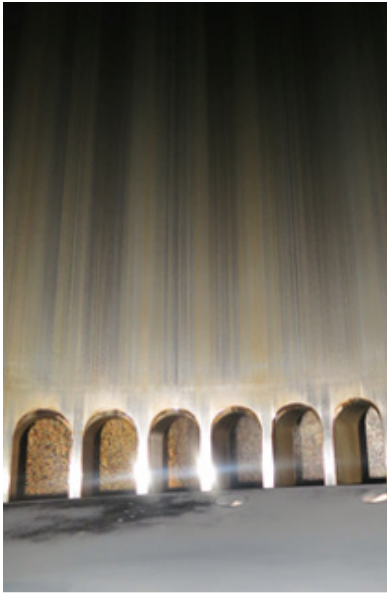
Condition: Cylinder liner with scoring marks

Acceptance: Critical condition

Action: Depending on piston ring condition unit should be overhauled and liner re-honed. If piston rings are in spotless condition, the unit can be kept in operation.

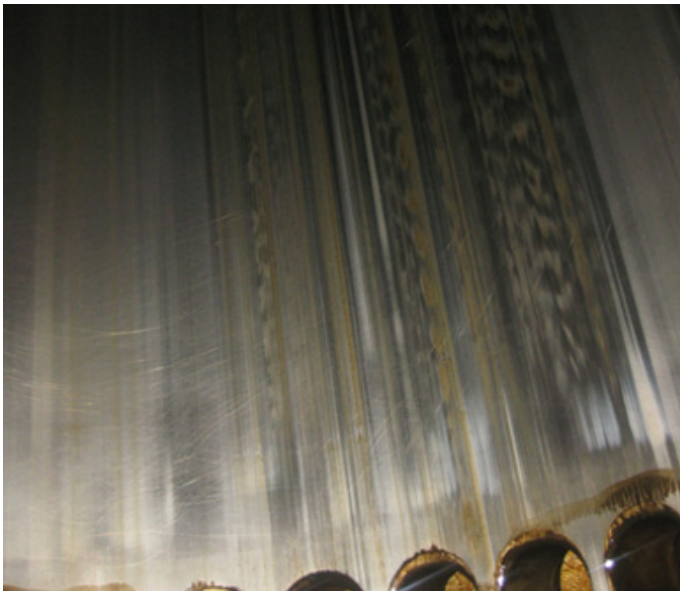
Condition: Liner with local scoring and scuffing, marks

Acceptance: Critical condition

Action: Depending on piston ring condition unit should be overhauled and liner dressed-up according to the procedure described in chapter 6.5 or re-honed. If piston rings are in spotless condition, the unit can be kept in operation.

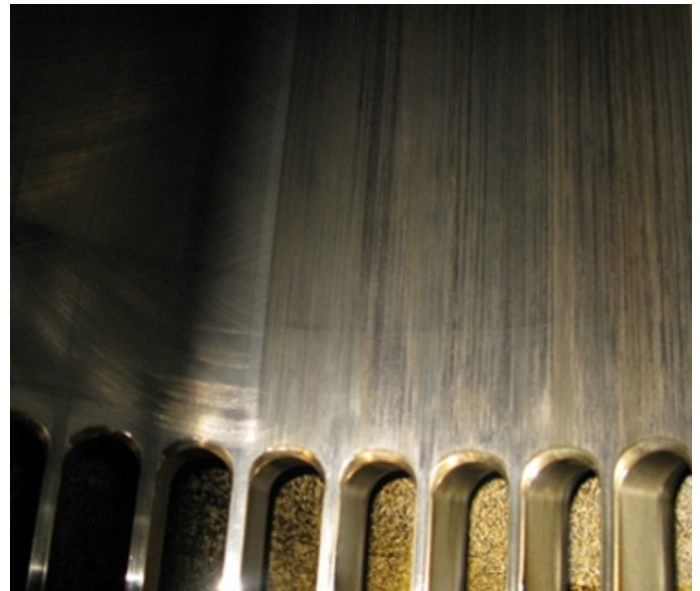
Condition: Scuffing marks on liner

Acceptance: Critical condition

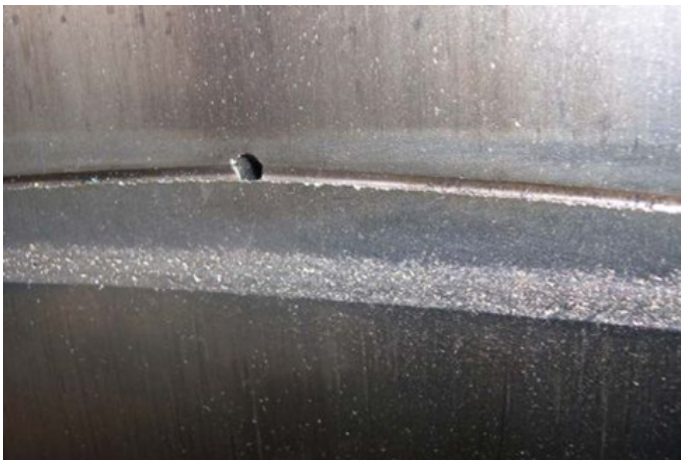
Condition: Scuffed liner with wear step in the region of the liner grooves

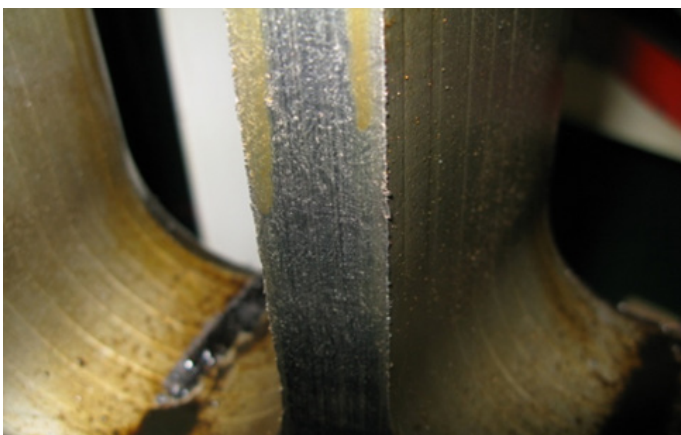
Condition: Scuffed liner with burrs on the edges of the scavenging air ports

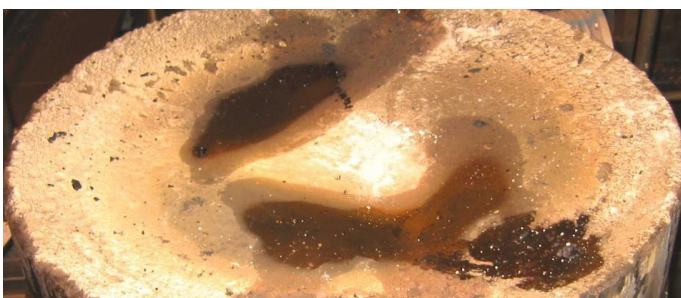
Condition: Carbon deposits on piston crown
Acceptance: Critical condition
Action: Piston underside drain oil analysis highly recommended. Consider to reduce feed rate or switch to a lower BN cylinder oil if not yet in use.

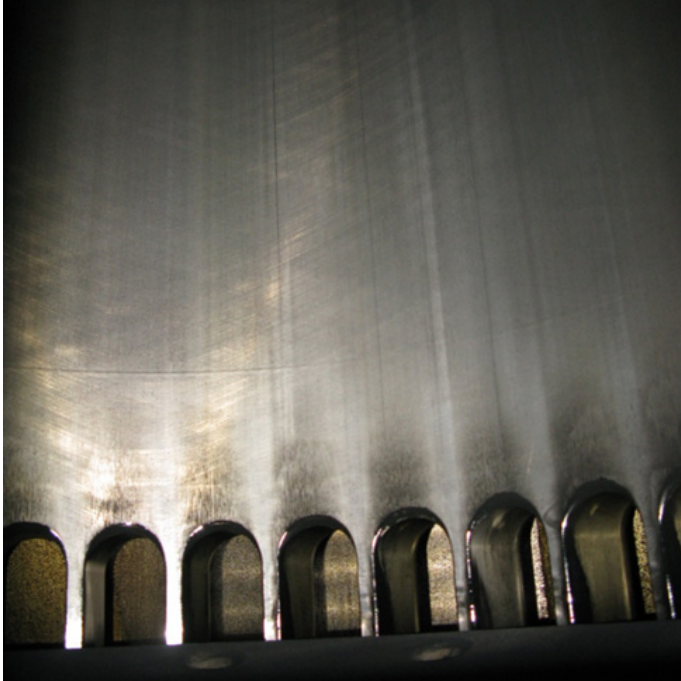
Condition of piston crown top and liner surface above scavenging air port

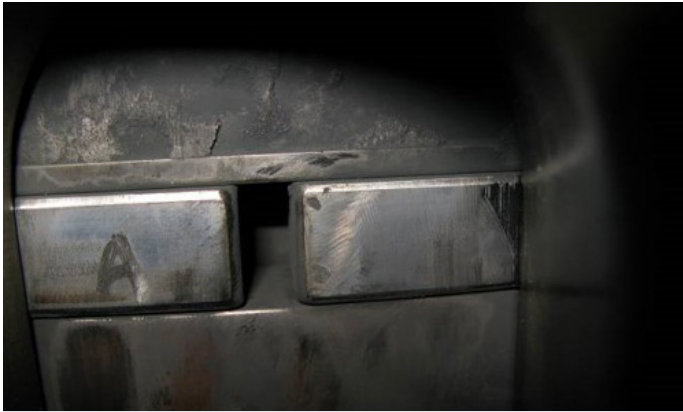
A ring lock (the ring lock is very important for the judgement of the piston running condition)
